## Reports from the Road Warriors

Submitted by Timber Line Electric & Control

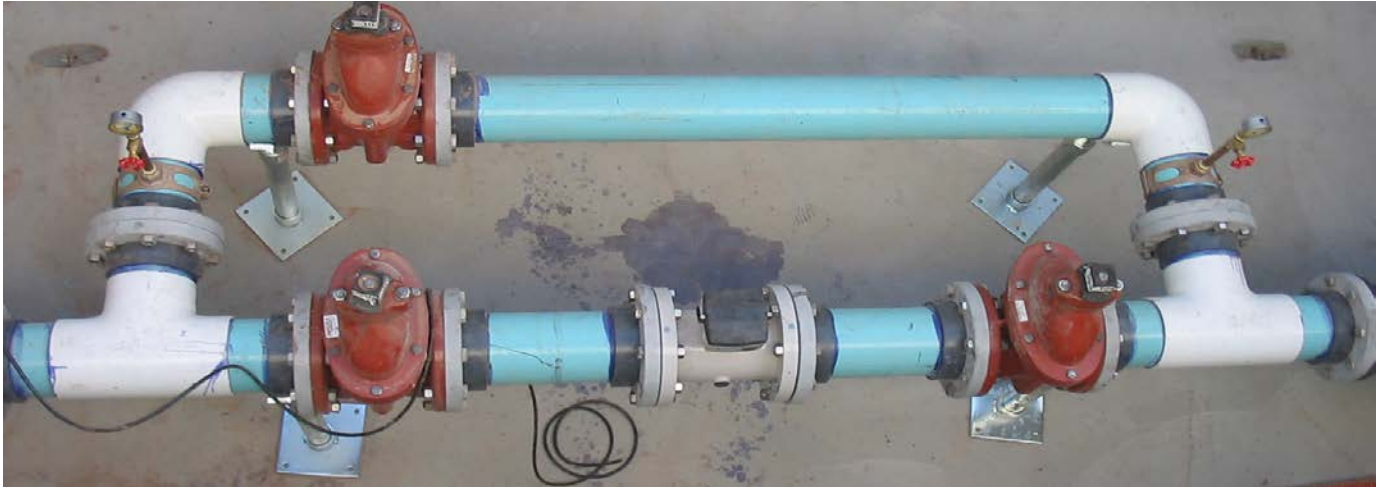
*It may look dry now, but when our technician arrived at this site to install a pressure transmitter, he found the vault flooded, with the water rising toward the electronics on the mag meter. Since the isolation valves were under water, the district staff made an emergency run for a gas powered sump pump. The pump arrived just in time to save the mag meter. Words to the wise - "A water-on-floor alarm, a 120 volt outlet, and a permanently mounted sump pump are MUCH cheaper than a new mag meter!" Check out the crack just to the left of mag meter.*

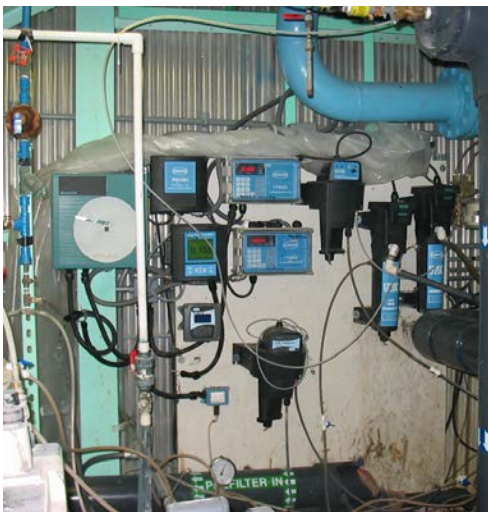
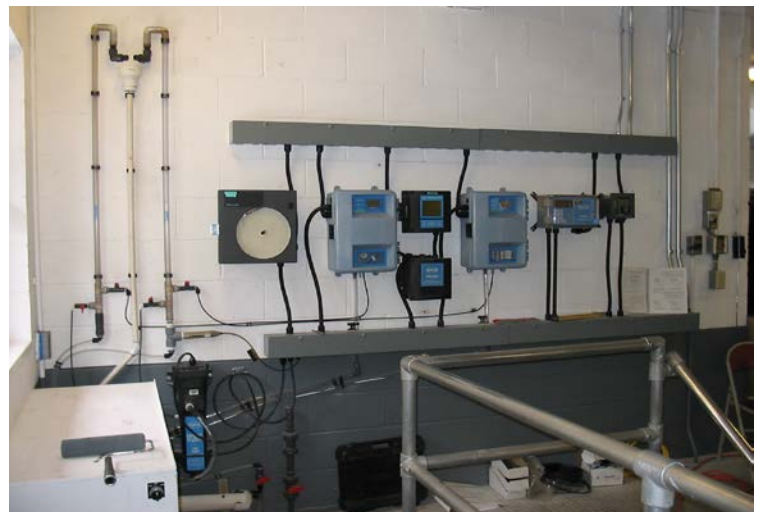
*Chaos or control? If your analytical gear installation is a bit of a hodge-podge like the picture on the left, check out what our Timber Line staff helped create for Castle Pines! Wireway is mounted at the top to receive control and power wiring, non-metallic flexduit keeps wires dry, and the lower wireway is off-set from the wall with unistrut to allow the conduit, cables, and drain tubes to exit in an orderly fashion. The operators really like the displays being at eye level!*
